Cambium Networks Cambium Networks, Inc. 3800 Golf Road Schaumburg, IL 60008, U.S.A.	Document Number	FSB 9084
	Revision	000v001
FIELD SERVICE BULLETIN 3GHz PMP450m Access Point	Application	Global
	Effective Date	12 May 2021
	Expiry Date	N/A

SUBJECT: 3GHz PMP450m Access Points not able to provide power to cnPulse/uGPS connected via AUX-Port

MODEL / SYSTEM AFFECTED: All PMP450m Access Points within this ESN/MAC Address range '0A-00-3E-60-85-4D' to '0A-00-3E-60-8A-65' are potentially impacted.

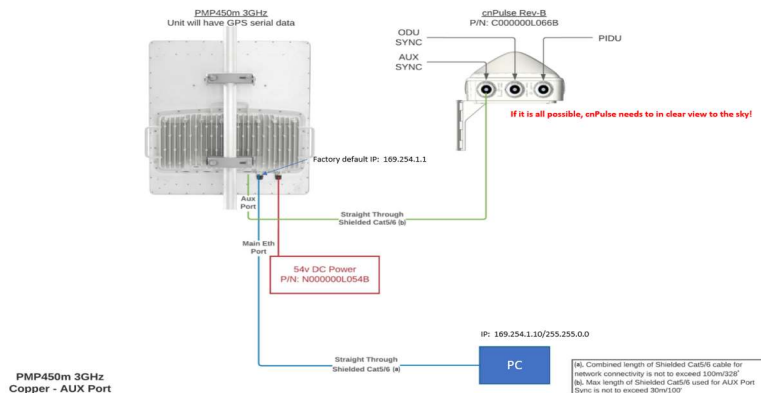
Fig-1: System under test network diagram – cnPulse

Symptom	Customers are reporting a symptom on the 3GHz PMP450m Access Points where a connected cnPulse/uGPS via its AUX-PORT has no sync or GPS data - GUI→ Home → Sync Status. Sync Status is in Searching, and GPS Data shows no Satellites information.
Current Status of Investigation	<p>We have identified a potential issue with some 3GHz PMP450m Access Points where they are not able to power up a cnPulse/uGPS device connected to their AUX port. If you are not using the AUX port of the 450m AP to power up cnPulse/uGPS, this issue will have no other impact. Cambium has determined that the units that are potentially impacted have ESN/MAC Address ranging from '<u>0A-00-3E-60-85-4D</u>' to '<u>0A-00-3E-60-8A-65</u>'.</p> <p>The procedure to screen the device to determine if the issue is present is described below. If you find that your unit is not performing as specified, please contact Cambium Technical Support to submit an RMA.</p>

- Configure, Fig.1:** Wiring and powering up the 3GHz 450m per Fig-1 above.
- Configure a static IP address on the PC with 169.254.1.10/255.255.0.0 – the default factory IP/subnet mask for 3G PMP450m AP.
 - Launch a browser and access the 450m management UI at <http://169.254.1.1/>
 - Leave the Login/password entries blank (not required for this procedure)
 - Enable the Sync setting, from landing page after login: Configuration → General, as below:

3. **Verification** - Connect cnPulse to 3GHz PMP450m AP Aux-port per Fig-1.
 - a. If the LED is blue around the cnPulse's Aux Sync port, then the 3GHz PMP450m AP is providing power to cnPulse and unit is working as expected.
 - b. If the LED is **not** blue around the cnPulse's Aux Sync Port, then the 3 GHz PMP 450 AP is impacted. **Please follow Cambium Networks RMA procedures.**
